Re: **Mr. Bob Prewitt Double M. Properties; Construction Stormwater; SIC 1522; NPDES Desk Audit; NPDES #NMR1002AG; December 12, 2021**

NPDES Compliance Inspection Report

**Legacy at Sierra Vista
Double M. Properties
NMR1002AG**

Site Photos Taken by Air Quality Bureau NMED
From Public Road

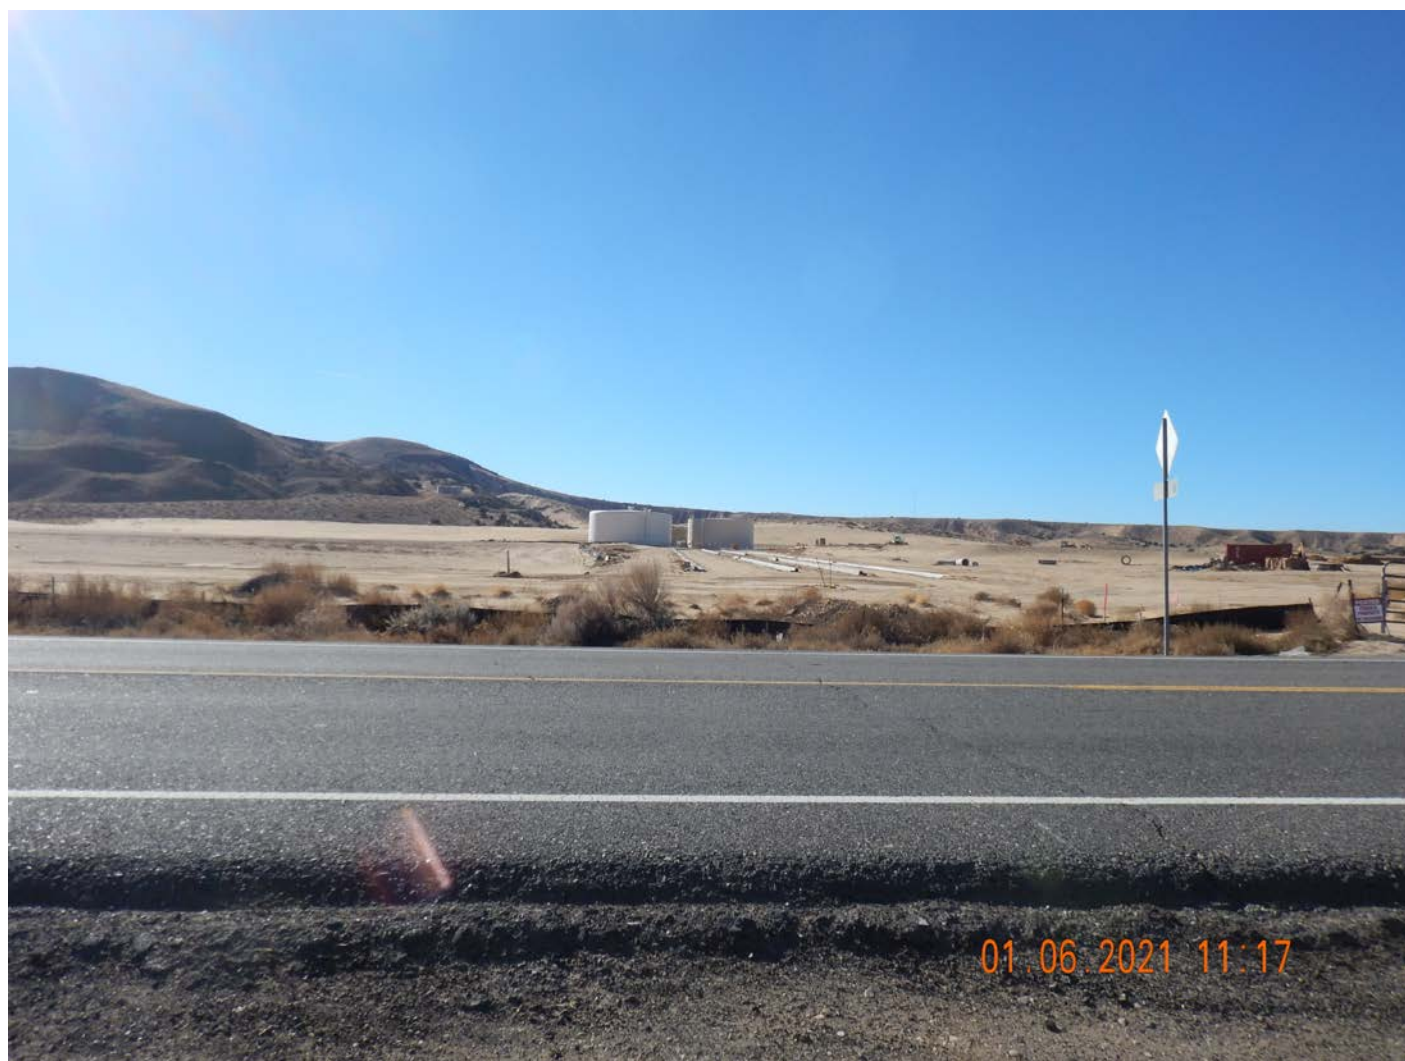
Photo # 1

Photographer: Jeremy Cahn	Date: December 6, 2021	Time: 1117
City/County: 0.43 Miles West of Jubilee Blvd. on NM-6 Los Lunas New Mexico/ Valencia County		
Location: Legacy at Sierra Vista,		
Subject: Part of the Sierra Vista construction site. Photo taken from public road.

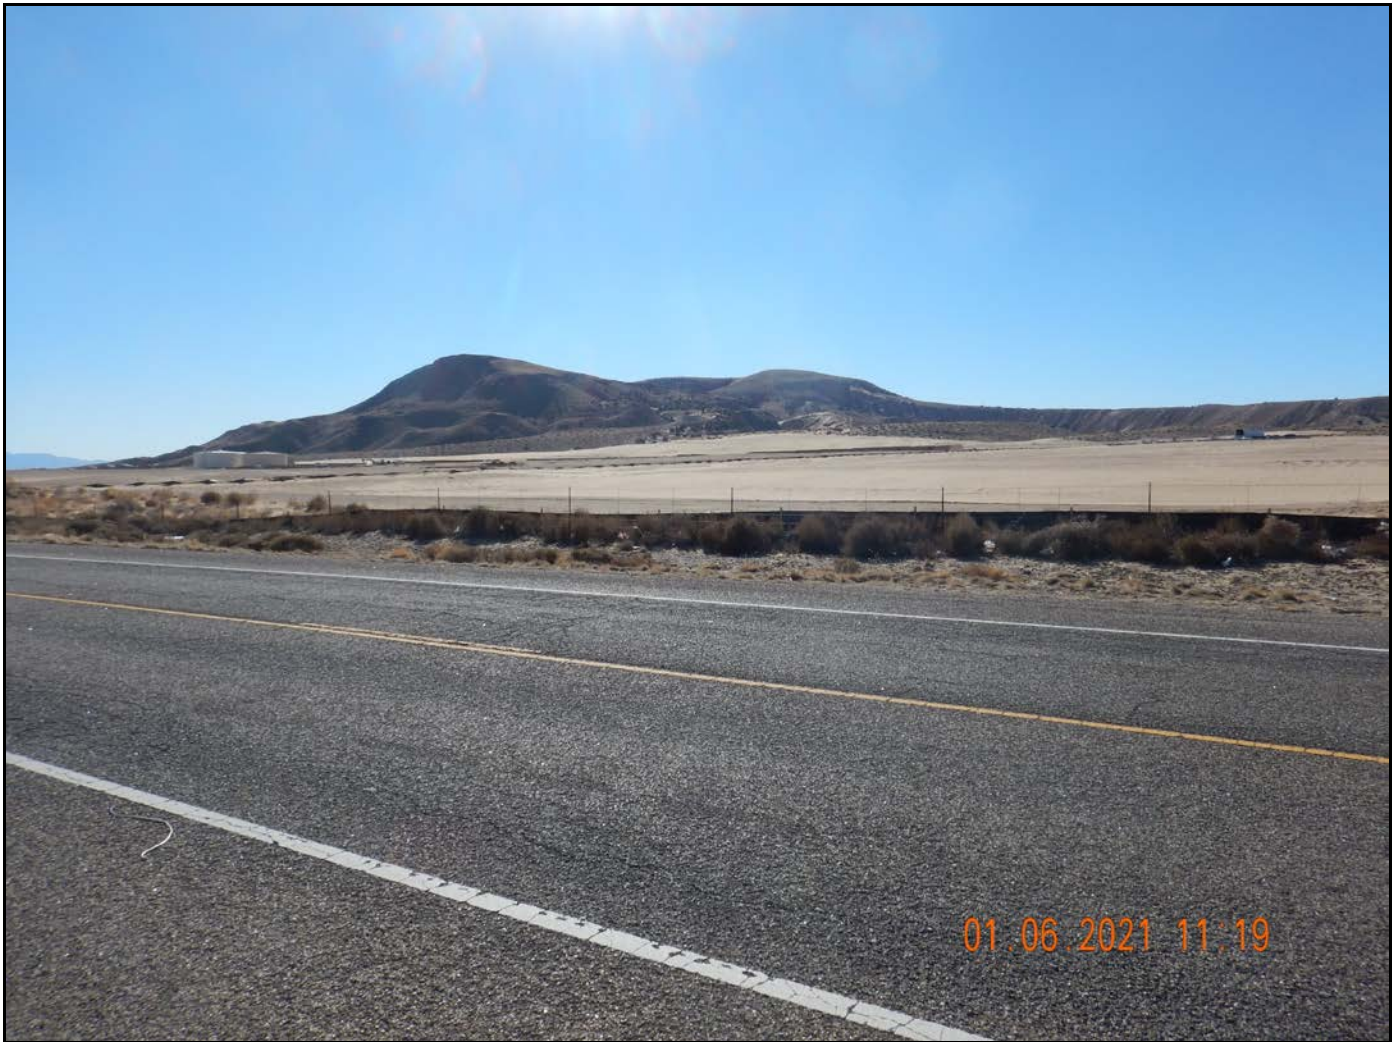
Photo # 2

Photographer: Jeremy Cahn	Date: December 6, 2021	Time: 1119
City/County: 0.43 Miles West of Jubilee Blvd. on NM-6 Los Lunas New Mexico/ Valencia County		
Location: Legacy at Sierra Vista,		
Subject: West side of Sierra Vista construction site. Photo taken from public road.

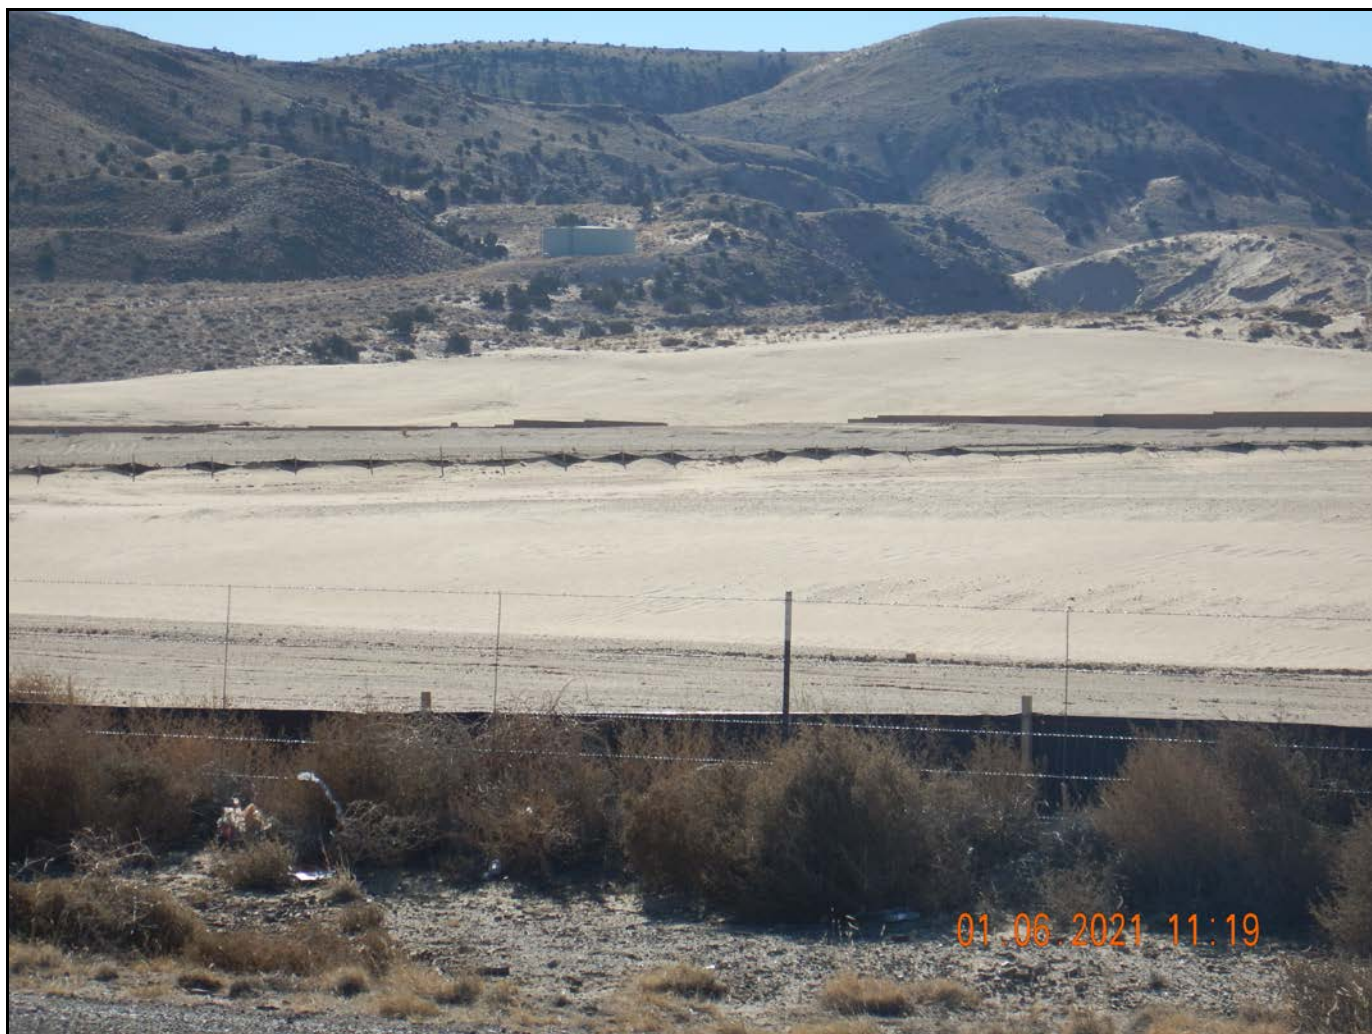
Photo # 3

- Silt fence BMP, see photo 3, does not appear to be maintained. Blowing sand has nearly covered the BMP.
- From the photos submitted by the NMED Air Quality Bureau and from many residents near the construction site, it appears no native topsoil was preserved.

Photographer: Jeremy Cahn	Date: December 6, 2021	Time: 1119
City/County: 0.43 Miles West of Jubilee Blvd. on NM-6 Los Lunas New Mexico/ Valencia County		
Location: Legacy at Sierra Vista,		
Subject: Silt fence running across site nearly covered by blowing sand. Photo taken from public road.

- b. Southern Slope, Hydroseed with Tackifier – November 2020.
- 5. Central/Eastern boundary Silt Fence for Dust Mitigation purposes – September 2020.
 - a. Removal of accumulated sand on Silt Fence for Dust Mitigation per S&EP2 Maintenance Log (previously noted).

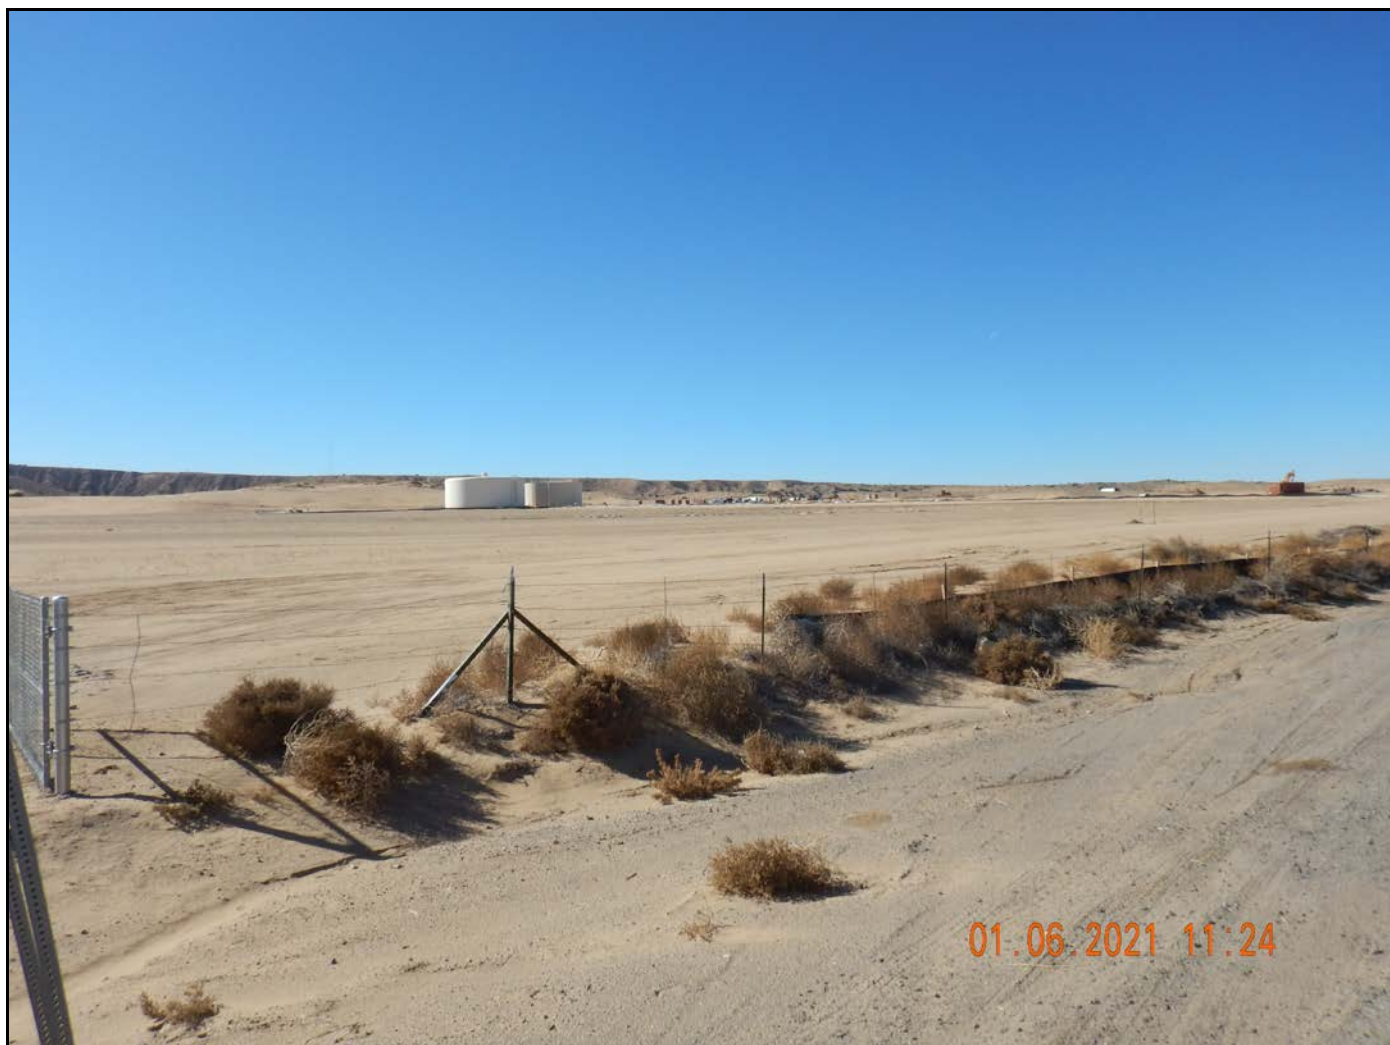
Photo # 4

Photographer: Jeremy Cahn	Date: December 6, 2021	Time: 1124
City/County: 0.43 Miles West of Jubilee Blvd. on NM-6 Los Lunas New Mexico/ Valencia County		
Location: Legacy at Sierra Vista,		
Subject: East side of Sierra Vista site looking West. Photo taken from public road.

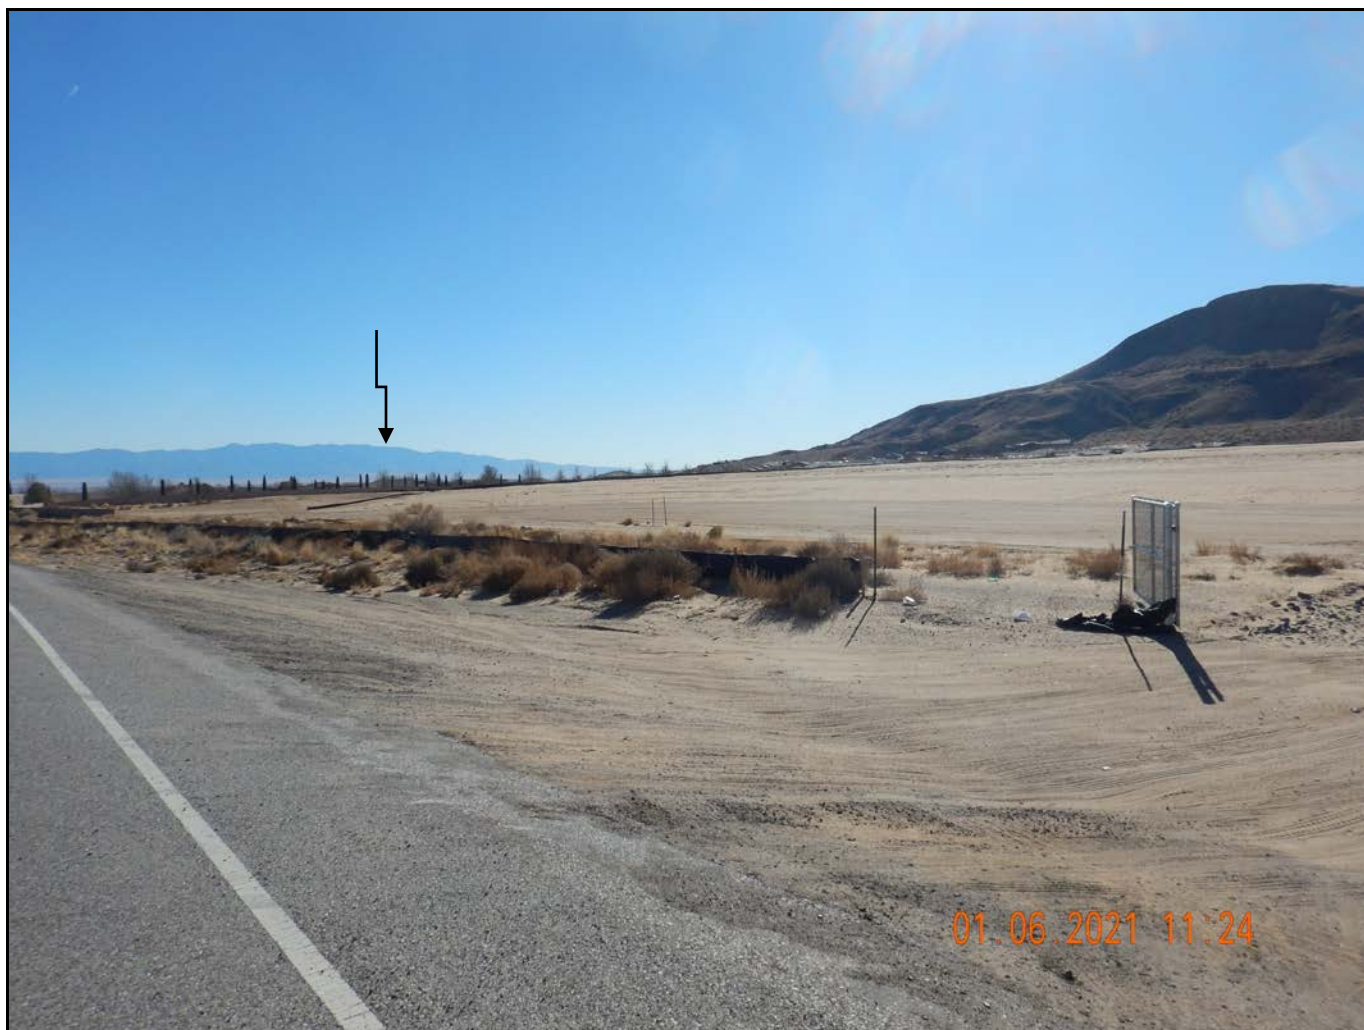
Photo # 5

Photographer: Jeremy Cahn	Date: December 6, 2021	Time: 1124
City/County: 0.43 Miles West of Jubilee Blvd. on NM-6 Los Lunas New Mexico/ Valencia County		
Location: Legacy at Sierra Vista,		
Subject: Looking East, note community next to construction site that is being impacted by blowing sand.

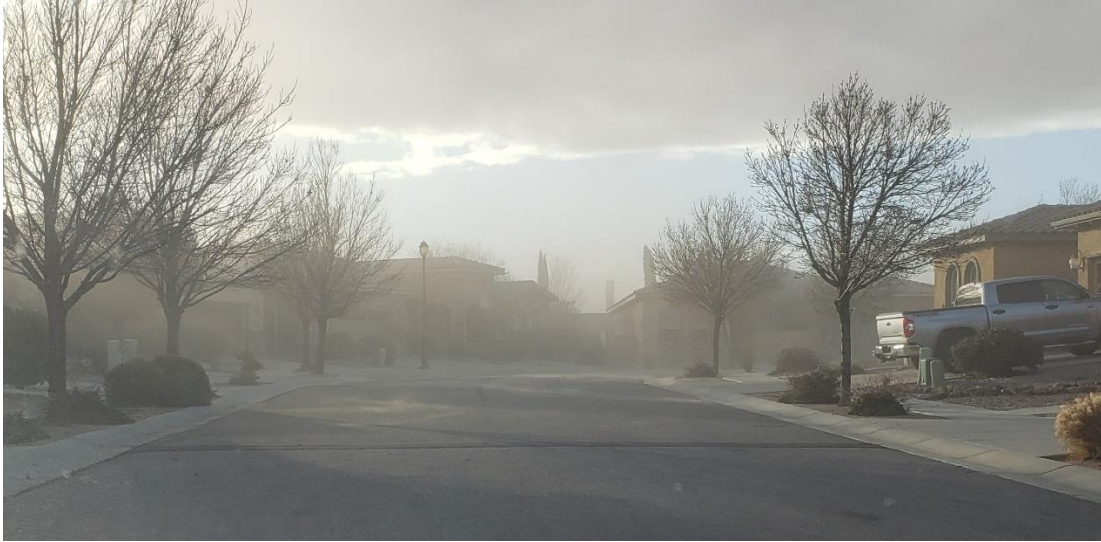
This picture is looking west on Zuni River Circle SW. The Sierra Vista Development is approximately 3 blocks to the west.

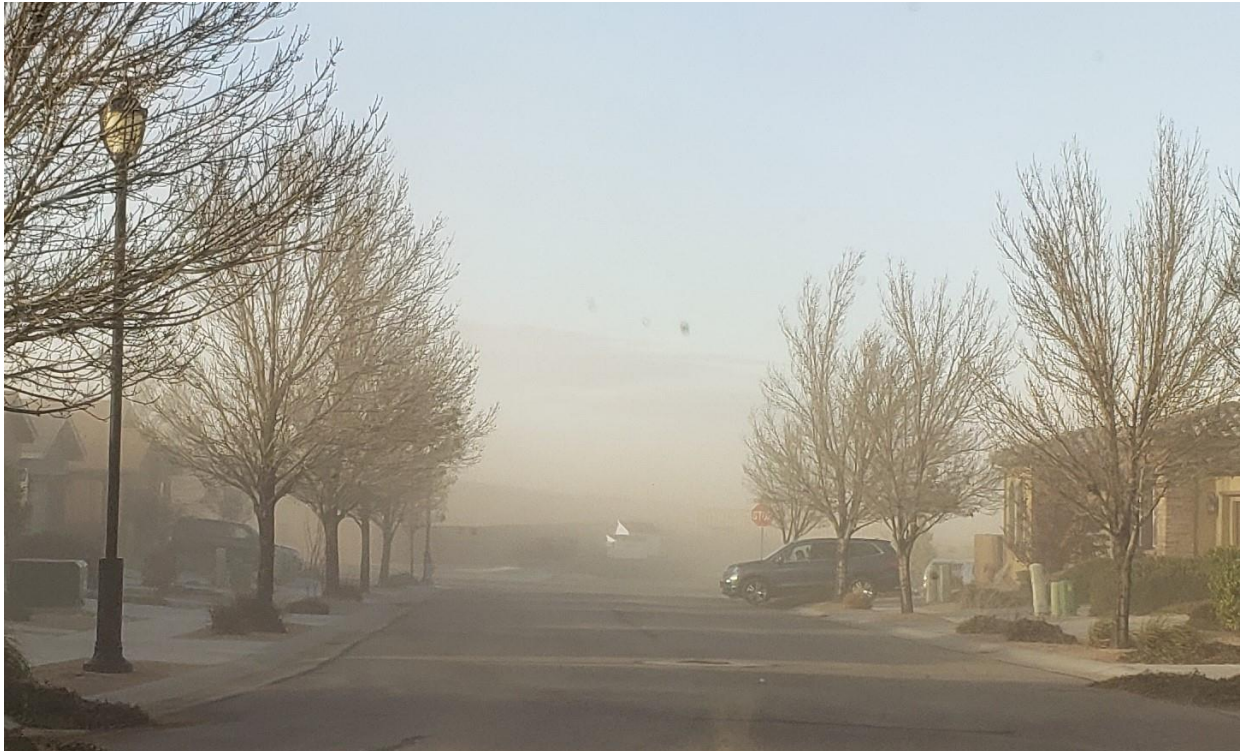
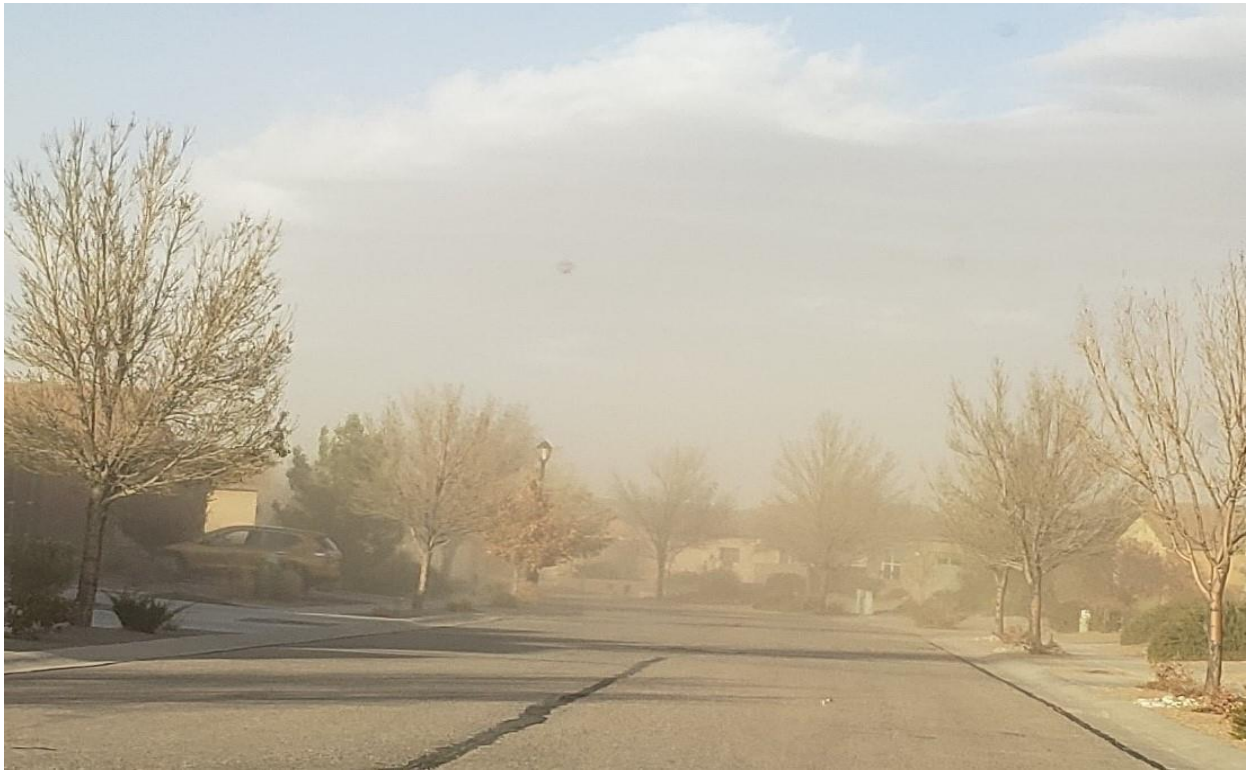
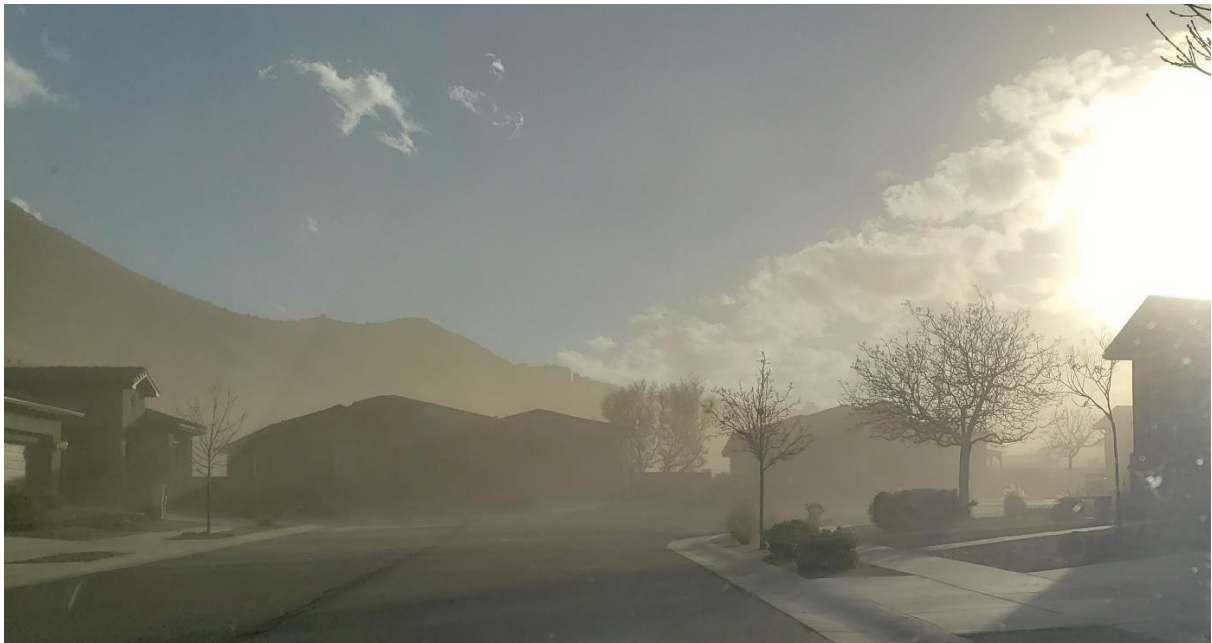
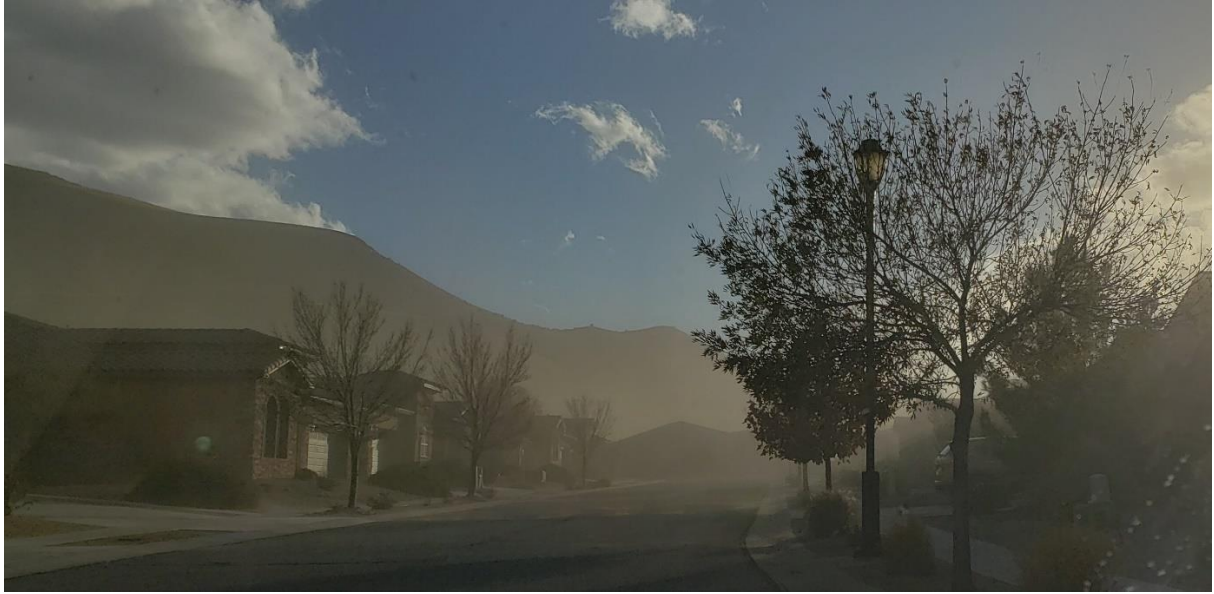
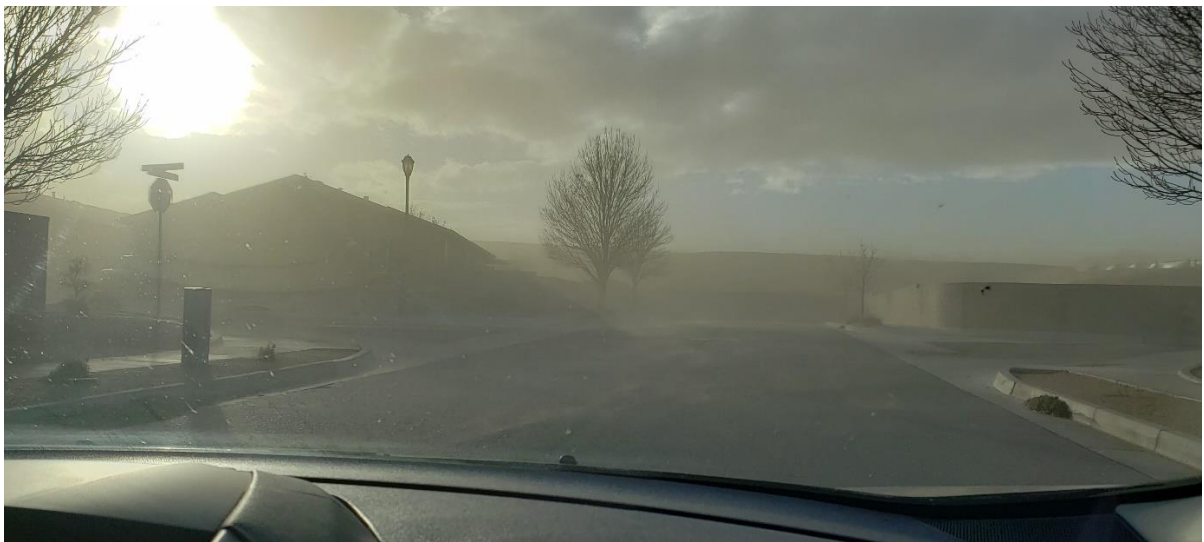
The following four pictures were taken on Promenade Trail during the sandstorm. This first picture is looking north to our recycling center.

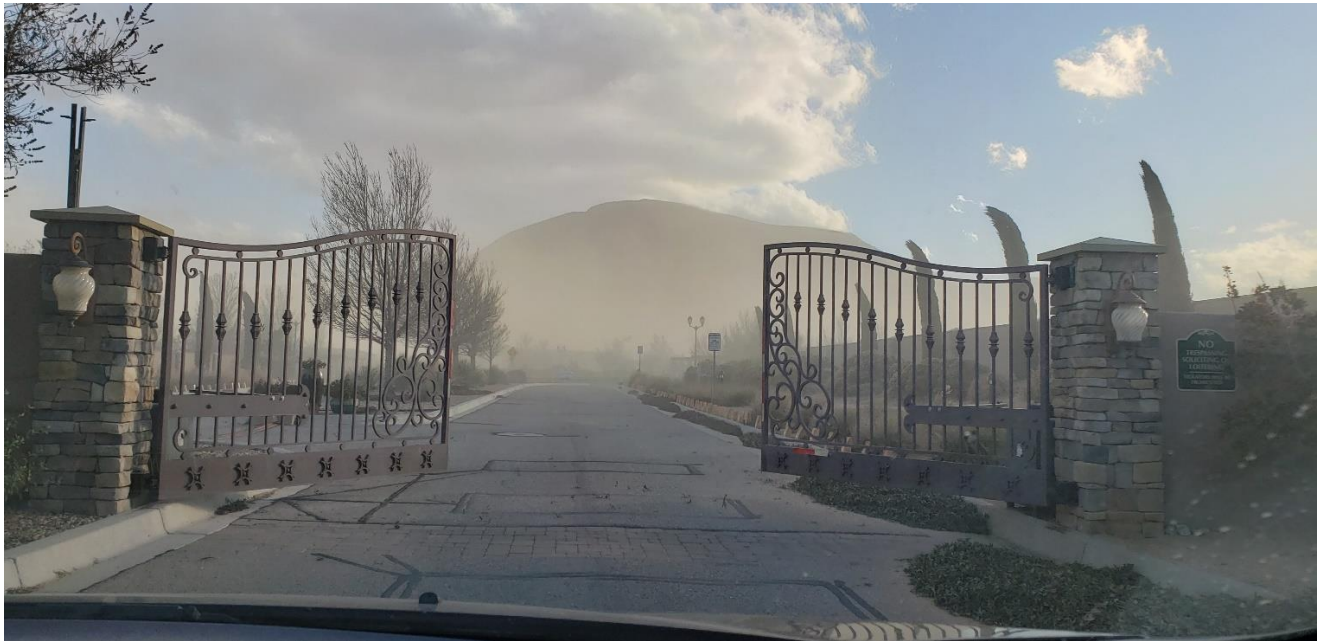
Showing the entrance gate area to Jubilee looking south toward El Cerro.

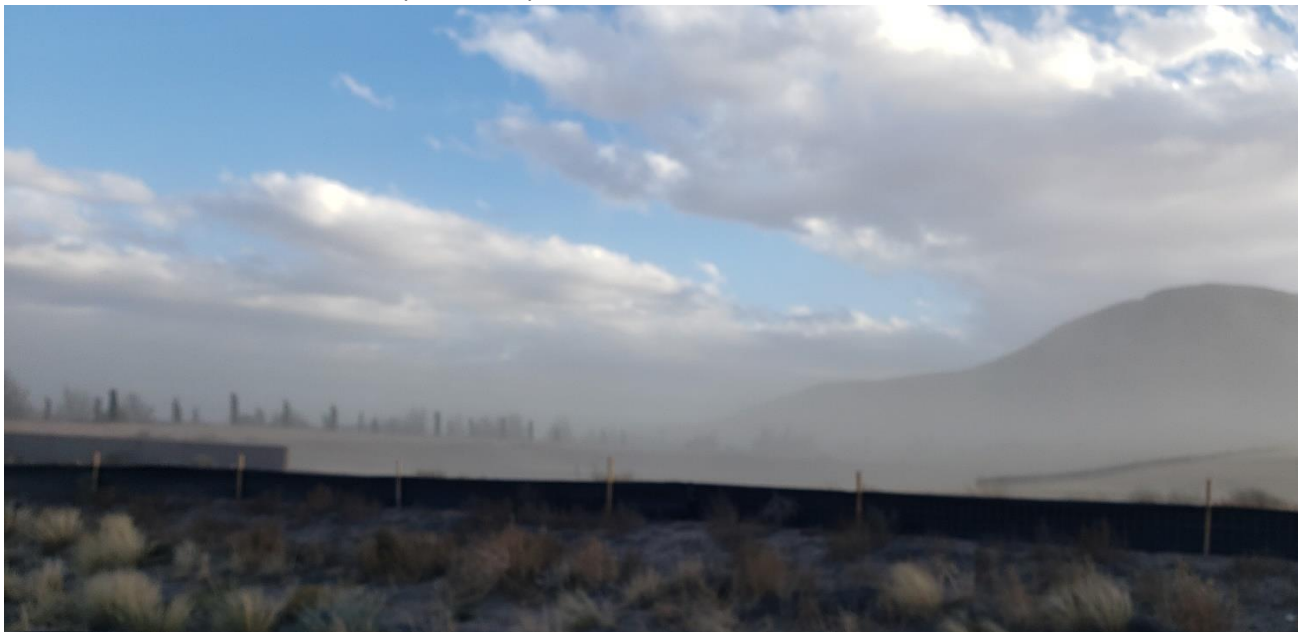
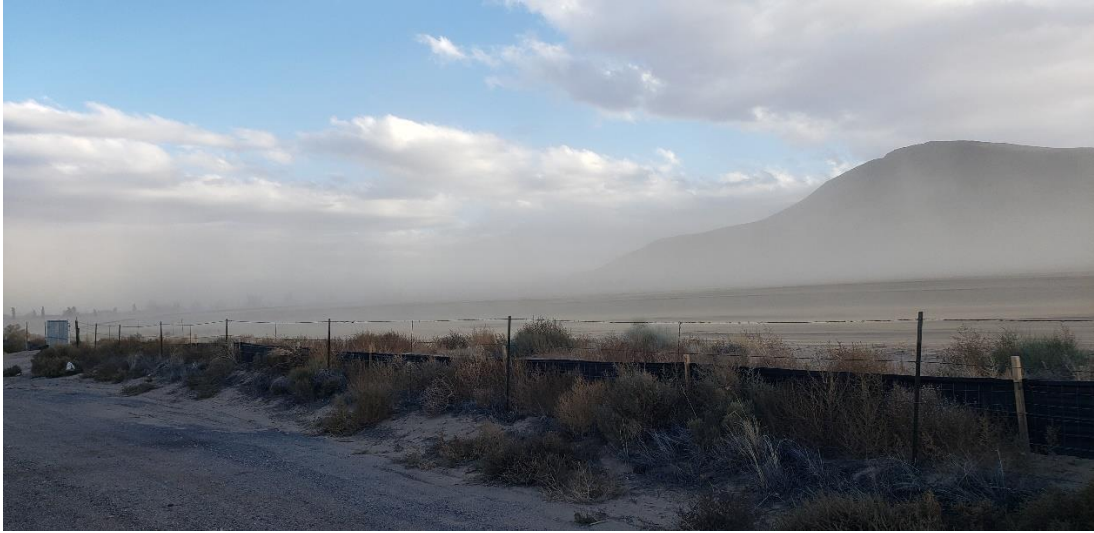
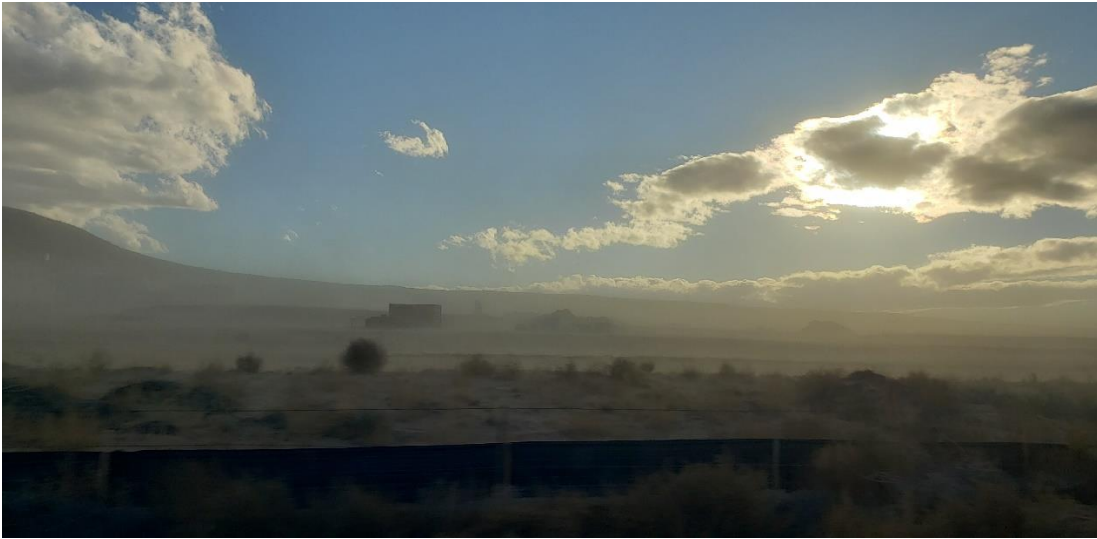
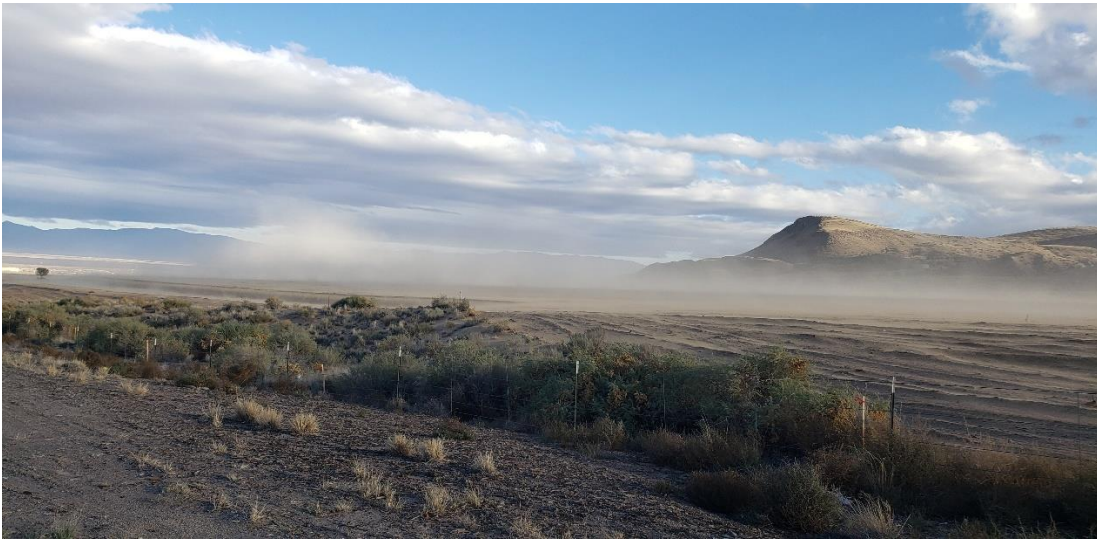
The following pictures are looking southeast from the El Cerro Trail Head as we were heading east on NM6. This particular photo shows the dust storm totally enveloping our community of Jubilee. Cypress trees in the left of the photo are part of the Jubilee entrance on Jubilee Boulevard.

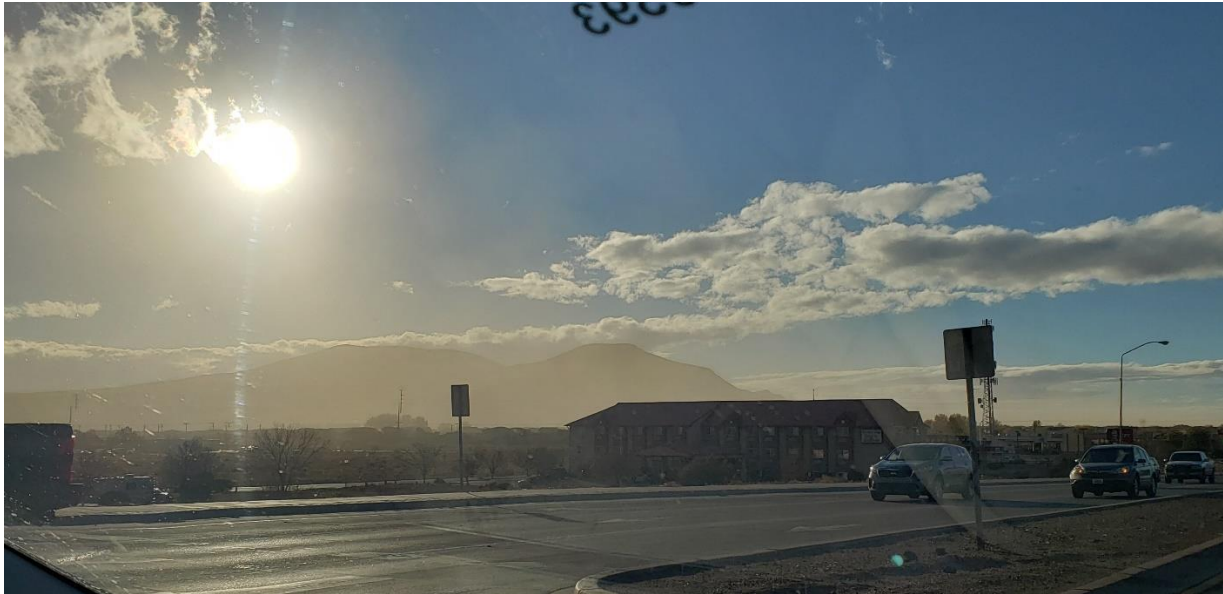
This last photo is taken heading west on NM6 looking southwest toward El Cerro showing sand blowing and over Huning Ranch and Jubilee at Los Lunas.
